CANADIAN FORCES FLIGHT SAFETY INVESTIGATION REPORT (FSIR)

FINAL REPORT

FILE NUMBER: 1010-11305 (DFS 2-4)

AIRCRAFT TYPE: CH 113 Labrador

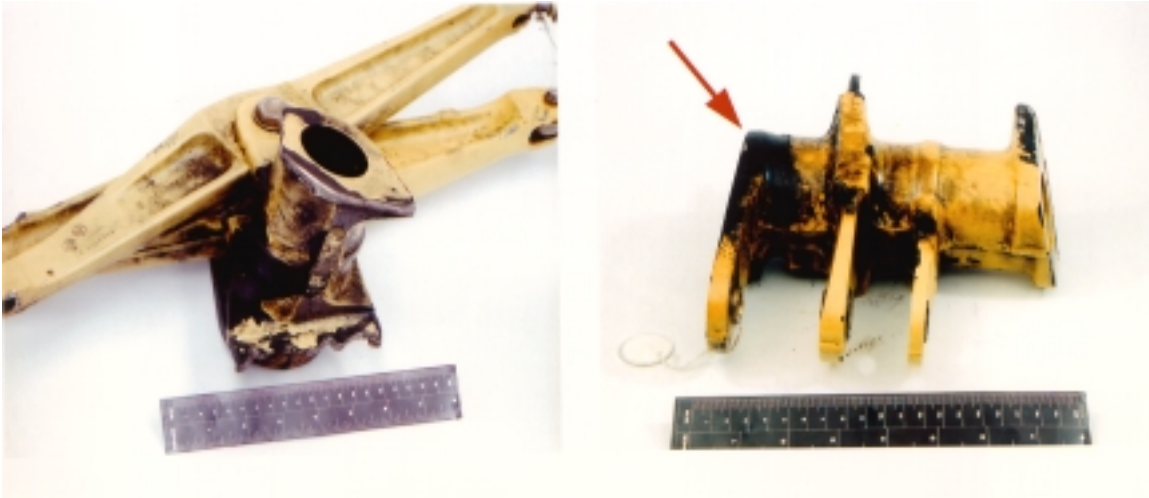
Photo 40/41 - Bell Crank Assembly - Note the signs of heating // Guignol; remarquez les dommages imputables à la chaleur

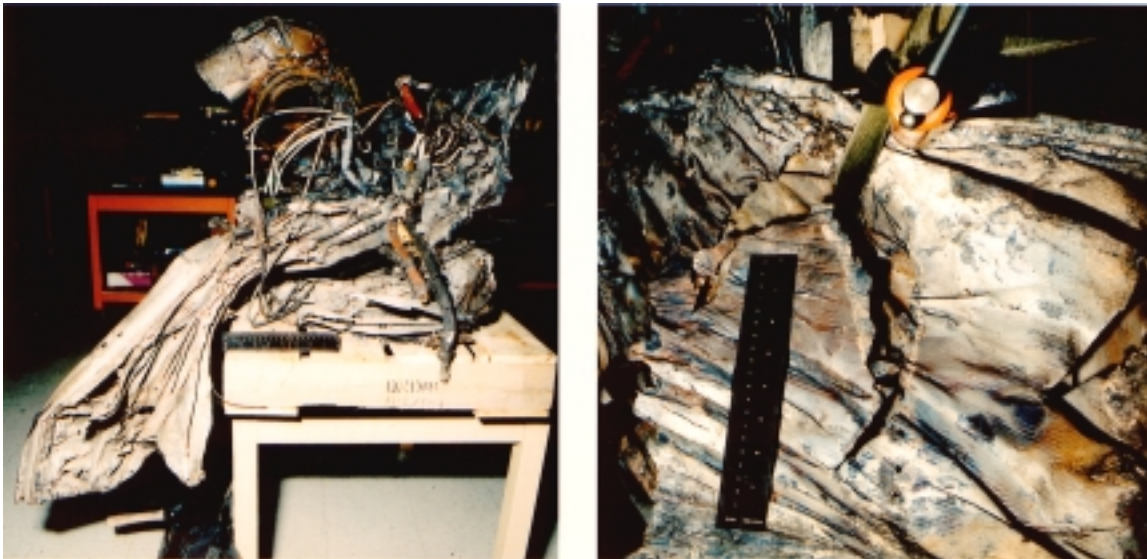
Photo 42/43 - Right (Number 2) Engine Access Door - Note the Severe "accordion" effect on the structure that had heat damage on interior folds when stretched // Porte d'accès au moteur de droite (numéro 2); remarquez l'important effet « accordéon » de la structure, qui présente des dommages imputables à la chaleur lorsqu'on l'étire

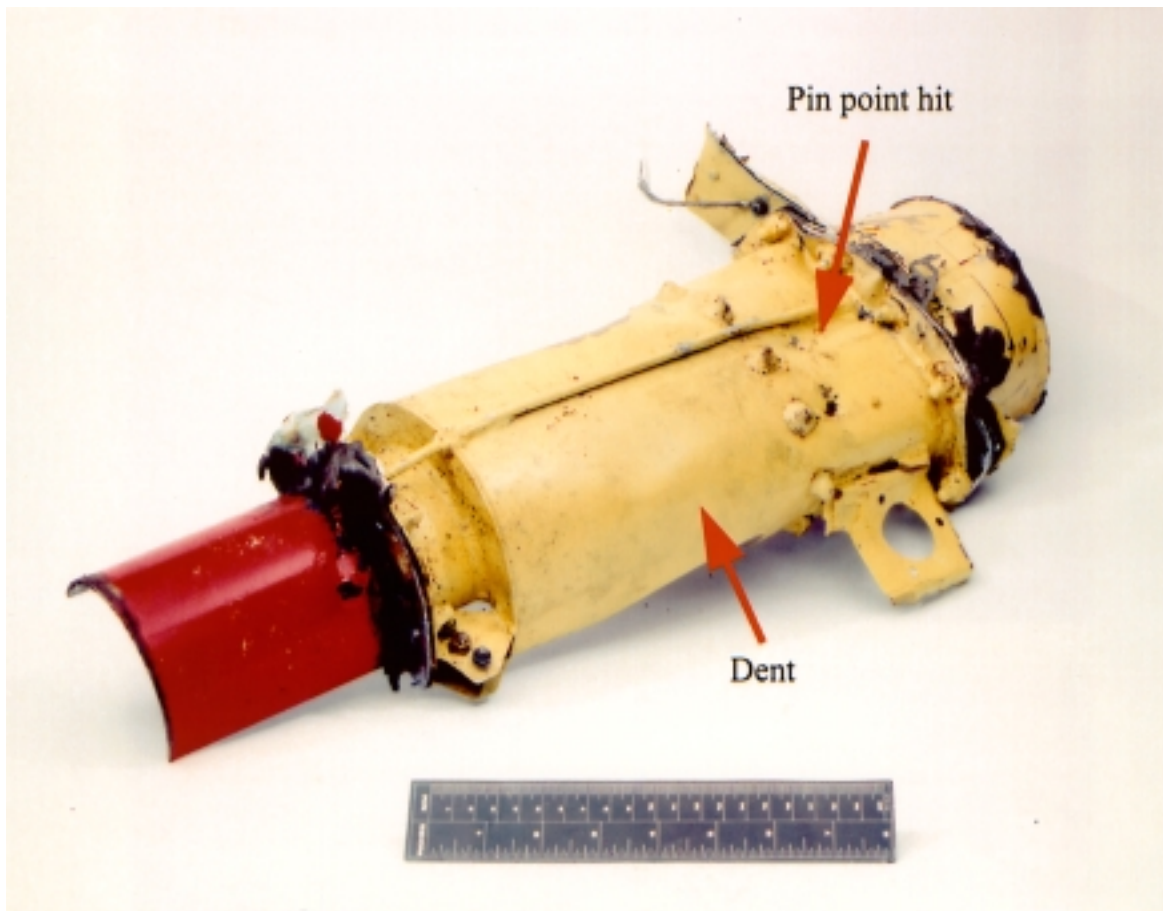
Photo 47 - RH Dump Tube and exterior view of puncture strike// Tube droit du vide-vite et vue extérieure des perforations

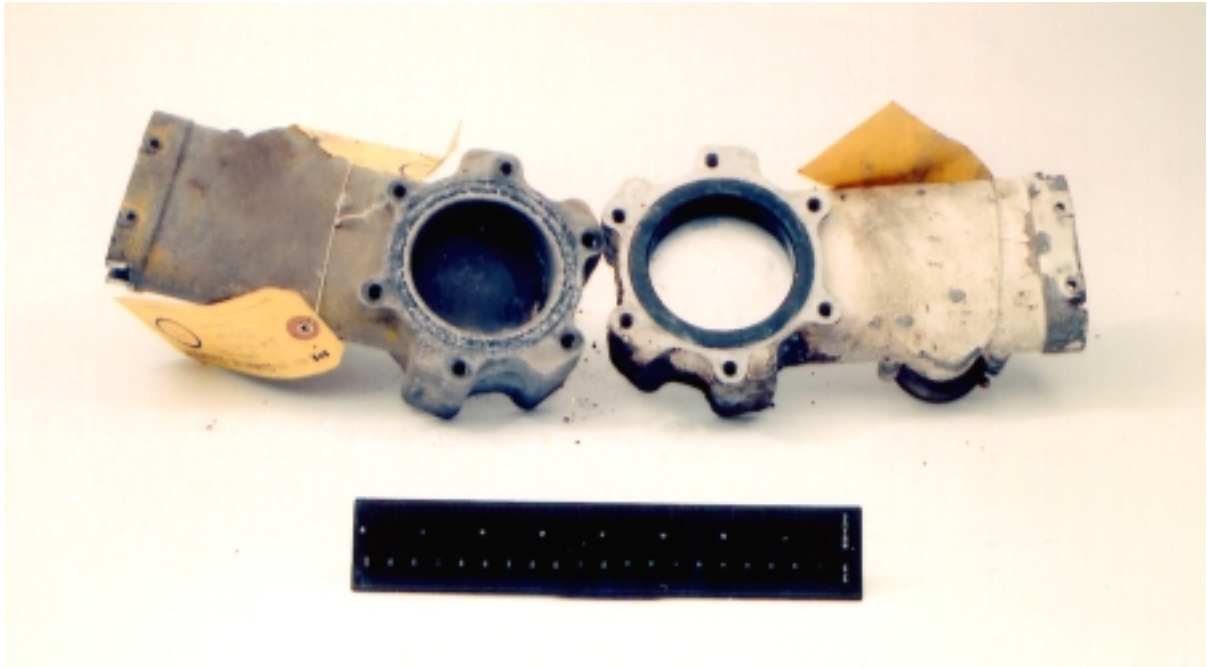
Photo 50 - Left and Right Fuel Dump valves (both in closed position)// Soupapes gauche et droite du vide-vite (toutes deux fermées)

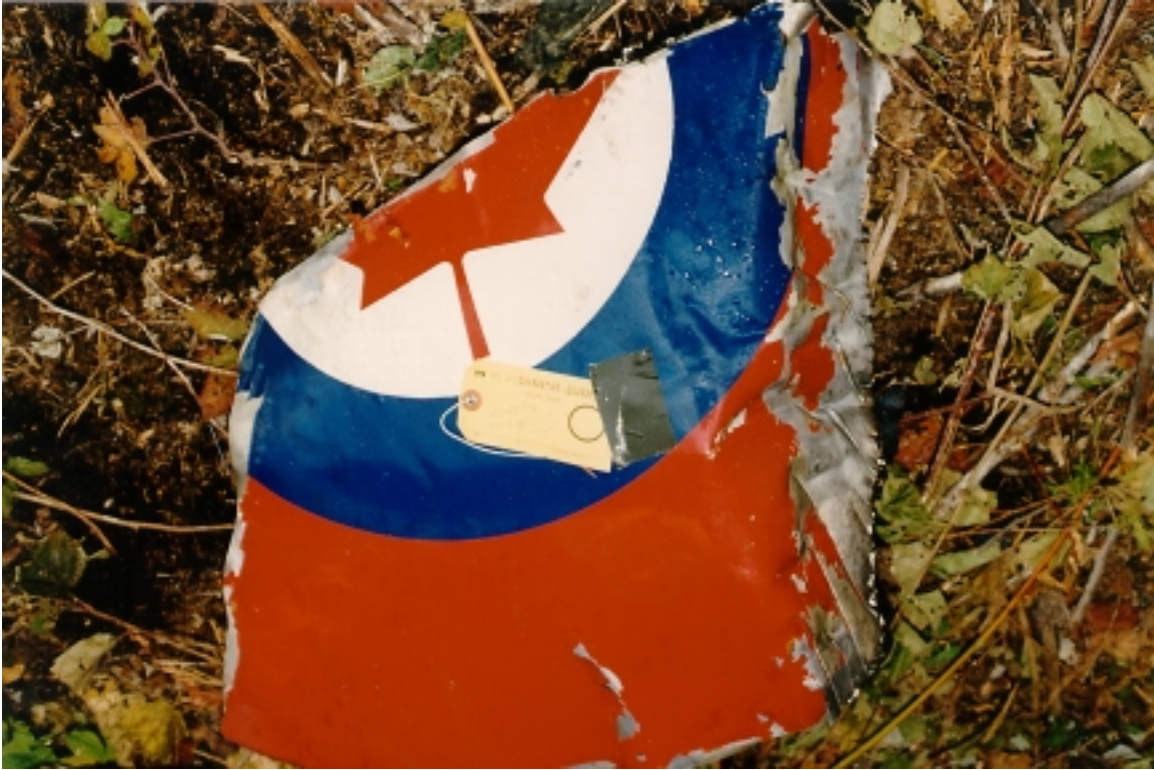
Photo 56 - Section of Left Stub Wing Fuel Tank - Note High Energy Impact created folds on right and no fire damage// Section du réservoir de carburant du moignon d'aile gauche; remarquez que la force de l'impact a plié la partie droite du réservoir et que le feu ne l'a pas endommagée
